Technical Report REMR-CS-53  
April 1997

*Repair, Evaluation, Maintenance, and Rehabilitation Research Program*

# **Applications of Roller-Compacted Concrete in Rehabilitation and Replacement of Hydraulic Structures**

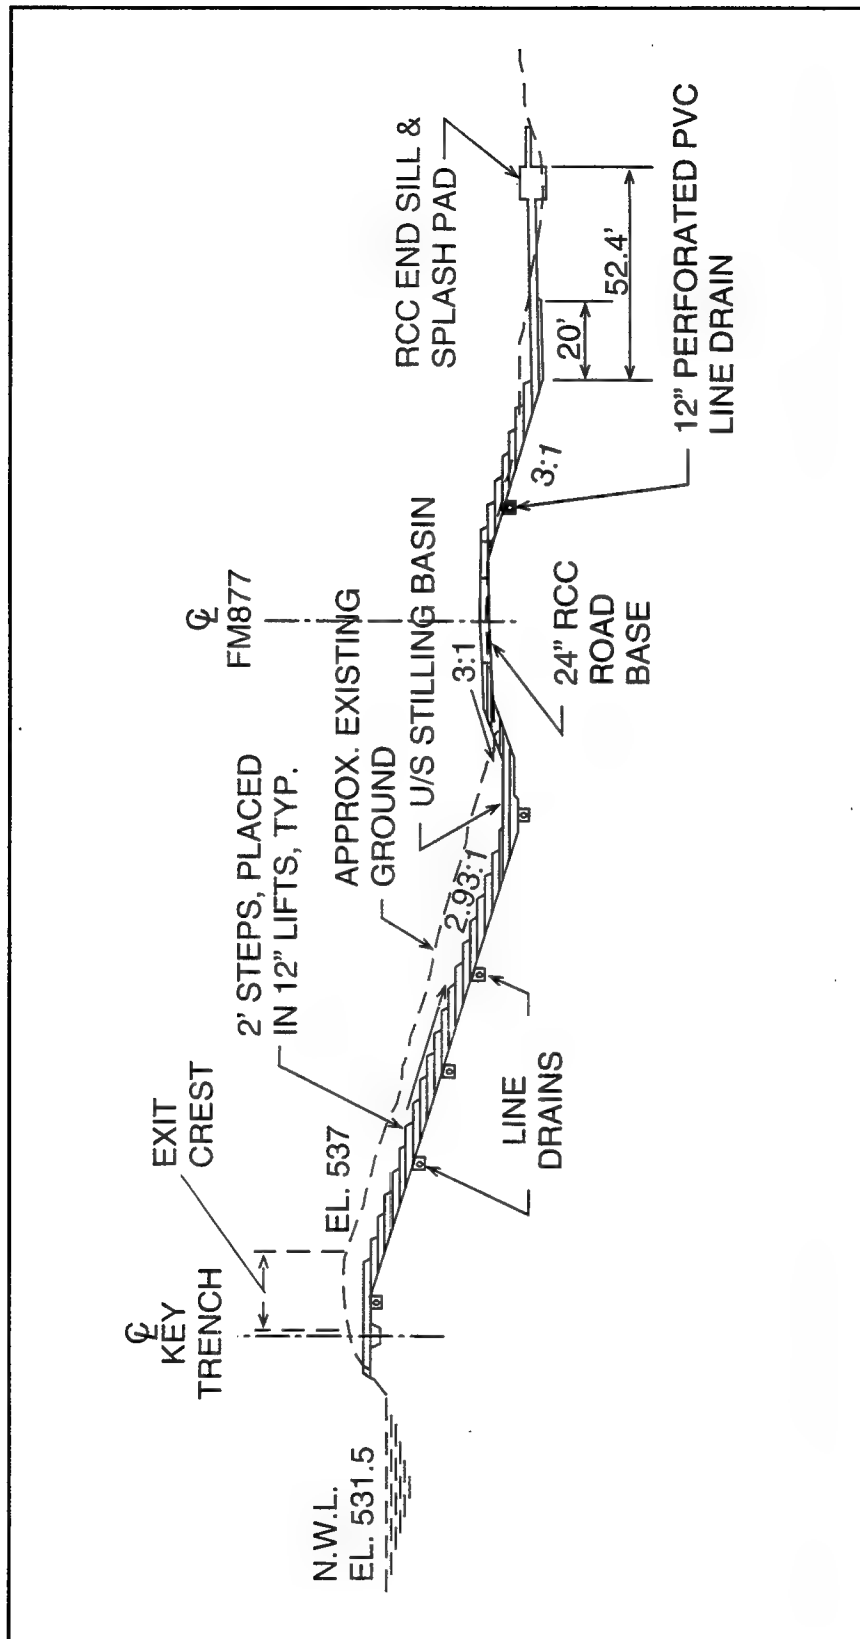
Several of the options were too costly, and others required more space than was available; for example, the top of the dam could not be raised more than 0.9 m (3 ft), and there was no room along the slope for a berm. The modification selected for stabilizing the downstream slope was to flatten it to 4:1 and to reinforce the soil with fiber grids. The modification selected to enable the dam to pass the PMF was to construct an RCC-overlay emergency spillway (Figure 85) and increase the top elevation of the dam with a parapet.

Figure 85. RCC emergency spillway, South Prong Dam. (Multiply inches by 25.4 to obtain millimetres and feet by 0.3048 to obtain metres)

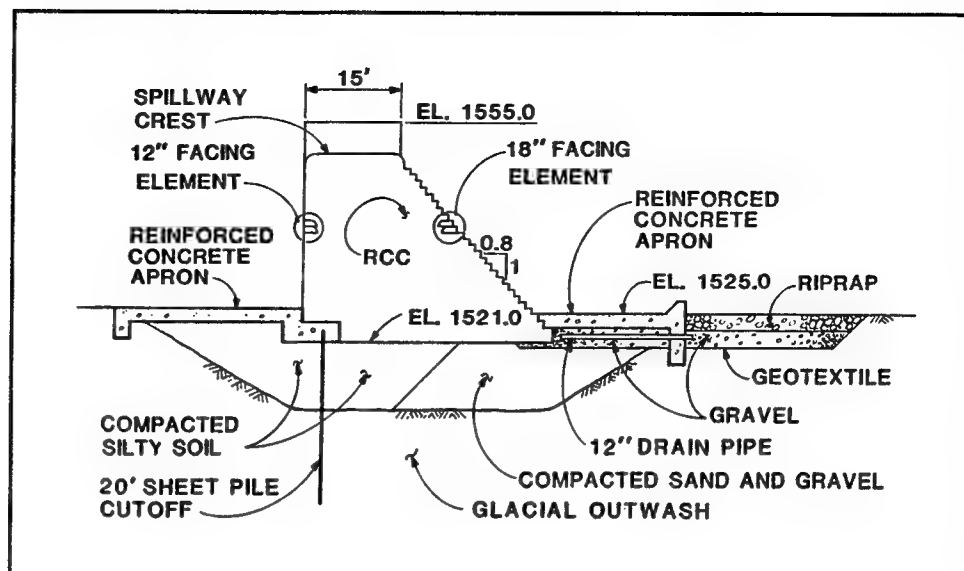
Figure 88. Cross section of RCC gravity dam constructed at Cedar Falls Project (courtesy of Benson, Verigin, and Carney 1988, ASCE). (Multiply inches by 25.4 to obtain millimetres and feet by 0.3048 to obtain metres)

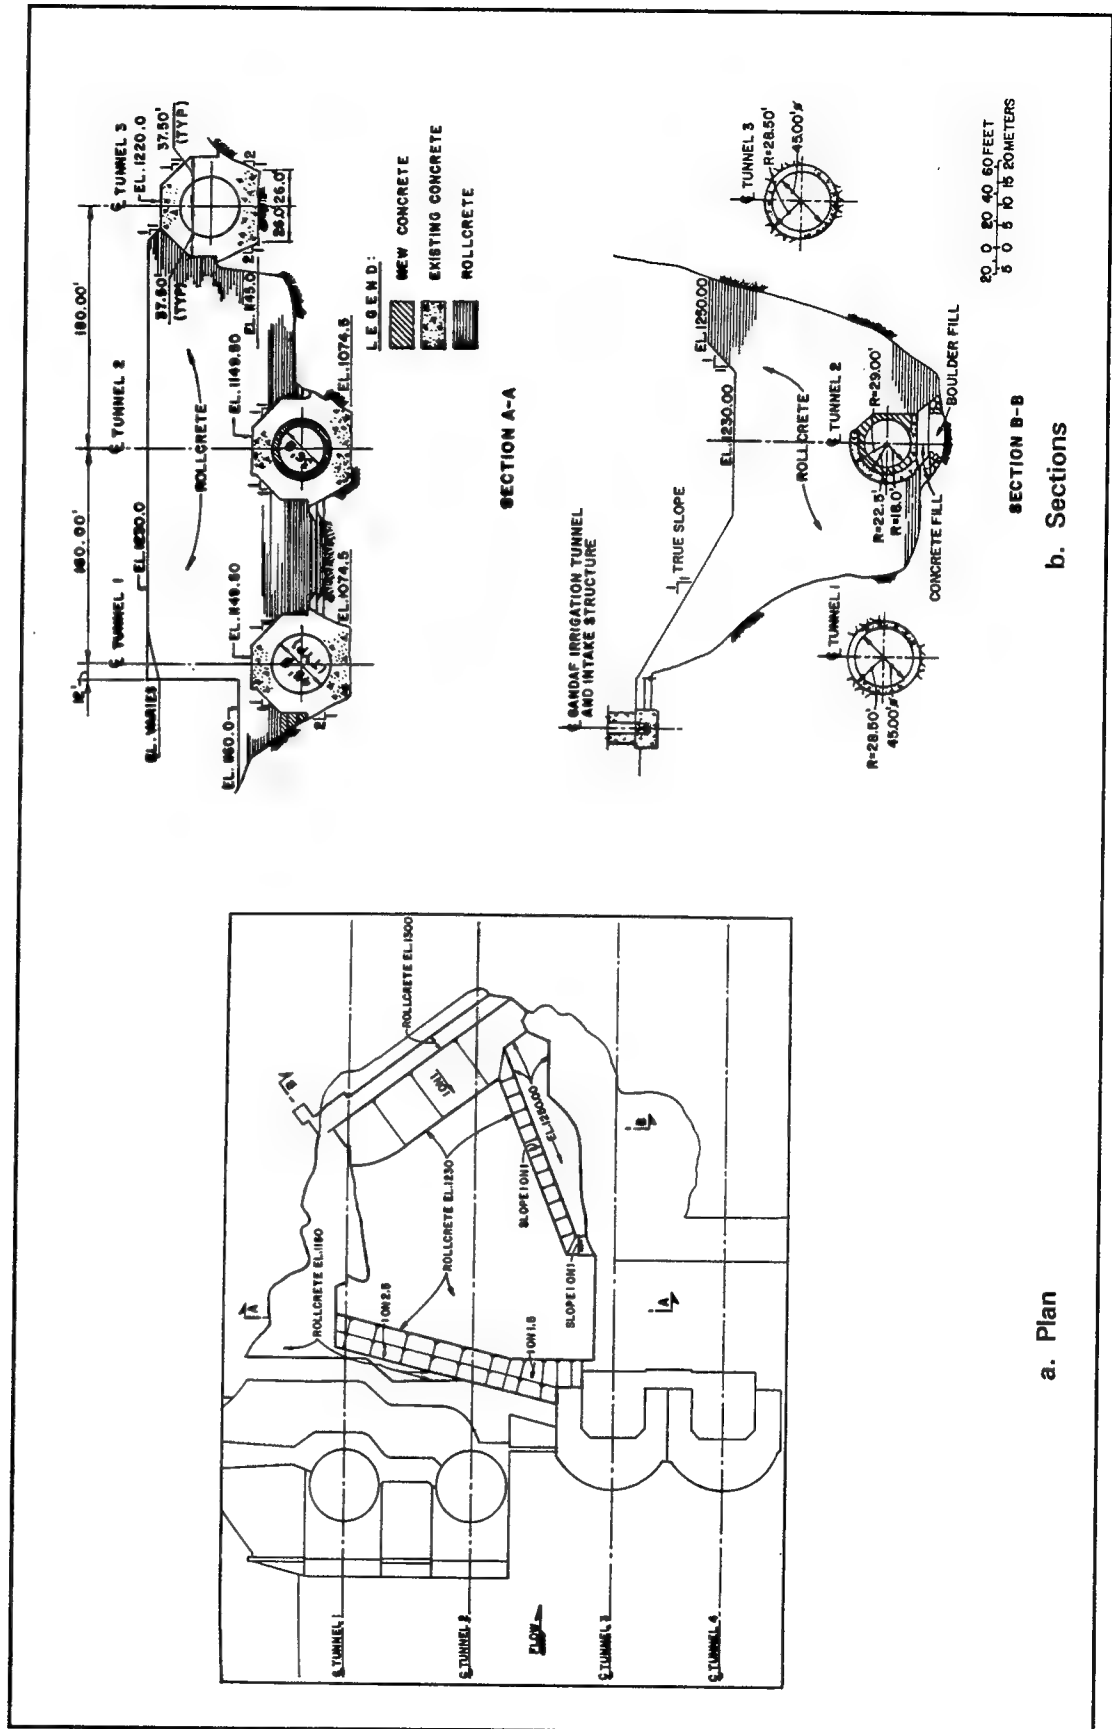
The collapsed portion of Tunnel No. 2 was approximately 76.2 m (250 ft) long. When the collapse occurred, the broken tunnel concrete, some of the reinforcement and supporting ribs, and about 756,000 cu m (1 million cu yd) of overlying bedrock and fill were washed out of the tunnel. The severity of the damage made it necessary to rebuild Tunnel No. 2, the area surrounding Tunnel No. 2, and to provide side support for Tunnels No. 1 and 3. This construction had to be completed within 6 months, before the next flood season.

Figure 106. Repair plan for Tunnel No. 2 intake, Tarbela Dam (courtesy of Johnson and Chao 1979)

The original repair plan was to remove the remaining section of the failed tunnel and put sand in the volume to be occupied by the new tunnel section simultaneously with the surrounding rollcrete. Later the sand would be excavated and the tunnel constructed in that space. However, because of the time factor, it became necessary to alter the plan. A decision was made to leave the remaining section of the tunnel in place and provide forming for the rollcrete on the right side of the section to form a cavity for reconstructing the tunnel with an 11-m (36-ft) inside diam, instead of 13.7 m (45 ft) because the larger diameter was no longer required for diversion. Because the conventional concrete production plant onsite was not capable of producing the required amount of concrete in the available time, engineers decided to use RCC. A rough test fill made by mixing cement with rounded boulder gravel (RBG) from the Indus River bed with a dozer confirmed that satisfactory results could be obtained. Most of the material passed a No. 20 sieve; that portion passing the No. 4 sieve was skip graded. Type I cement (the only type available in the required quantities) was used. Time restrictions prevented any action to control temperature in the RCC. However, placement was scheduled for January and February when the air temperature would range from 6.7 to 18.5 deg C (44 to 65 deg F), and the RBG was cool as it was excavated from near-river groundwater level. The repair plan for Tunnel No. 2 intake is shown in Figure 106.

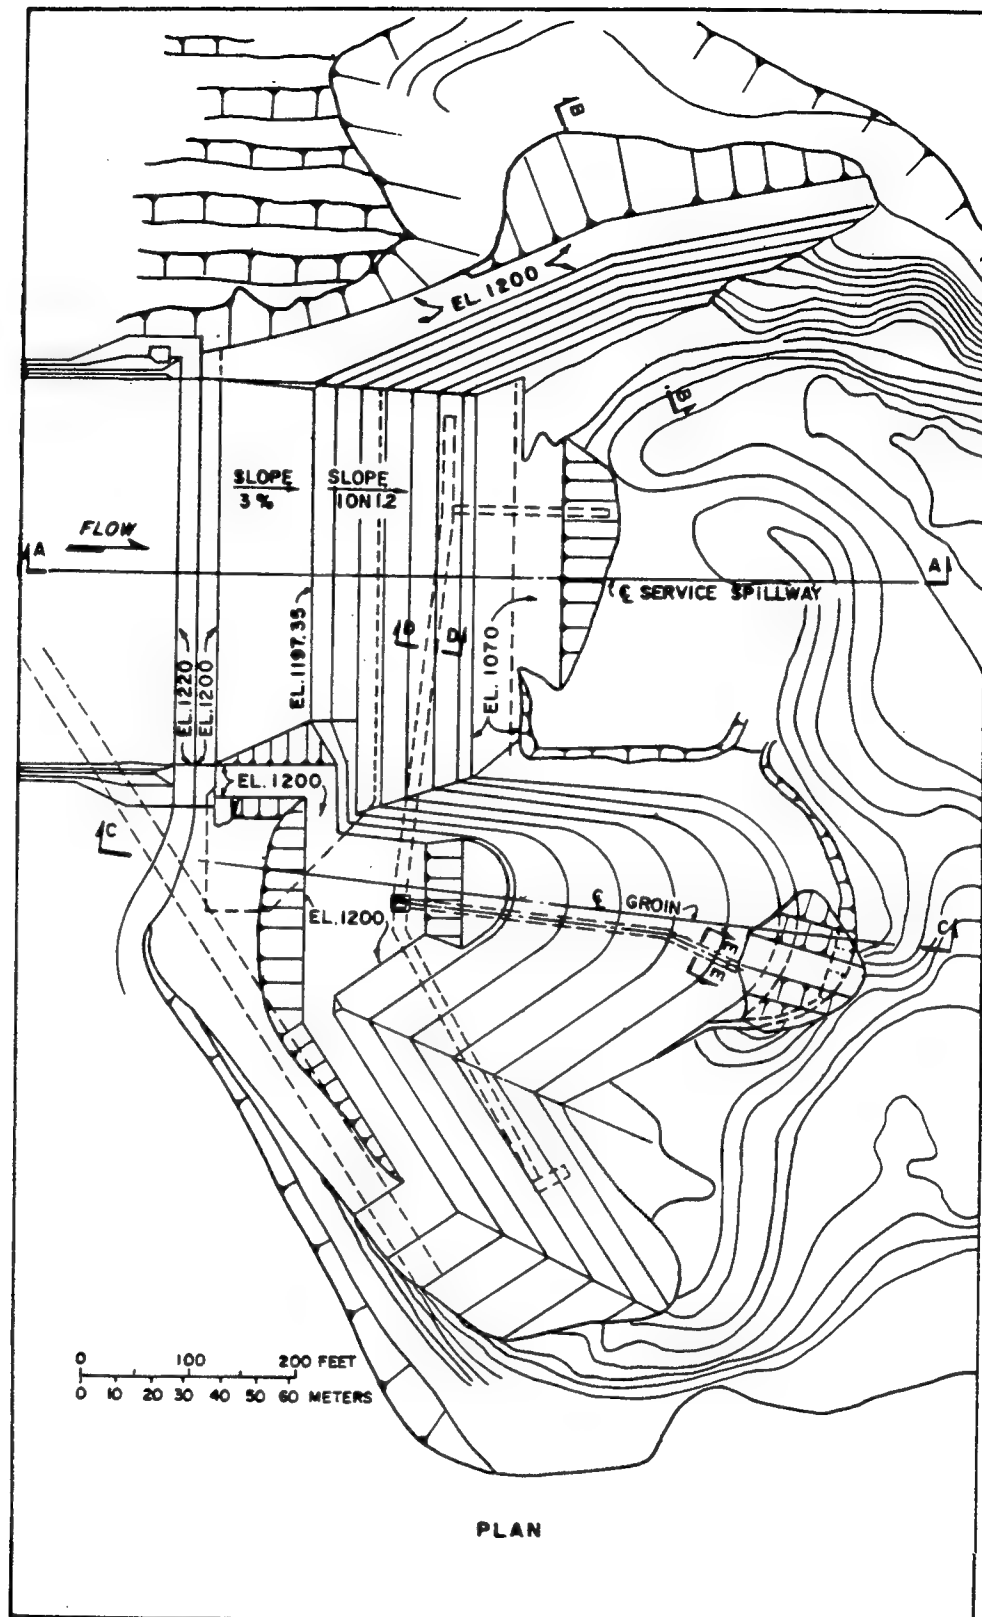
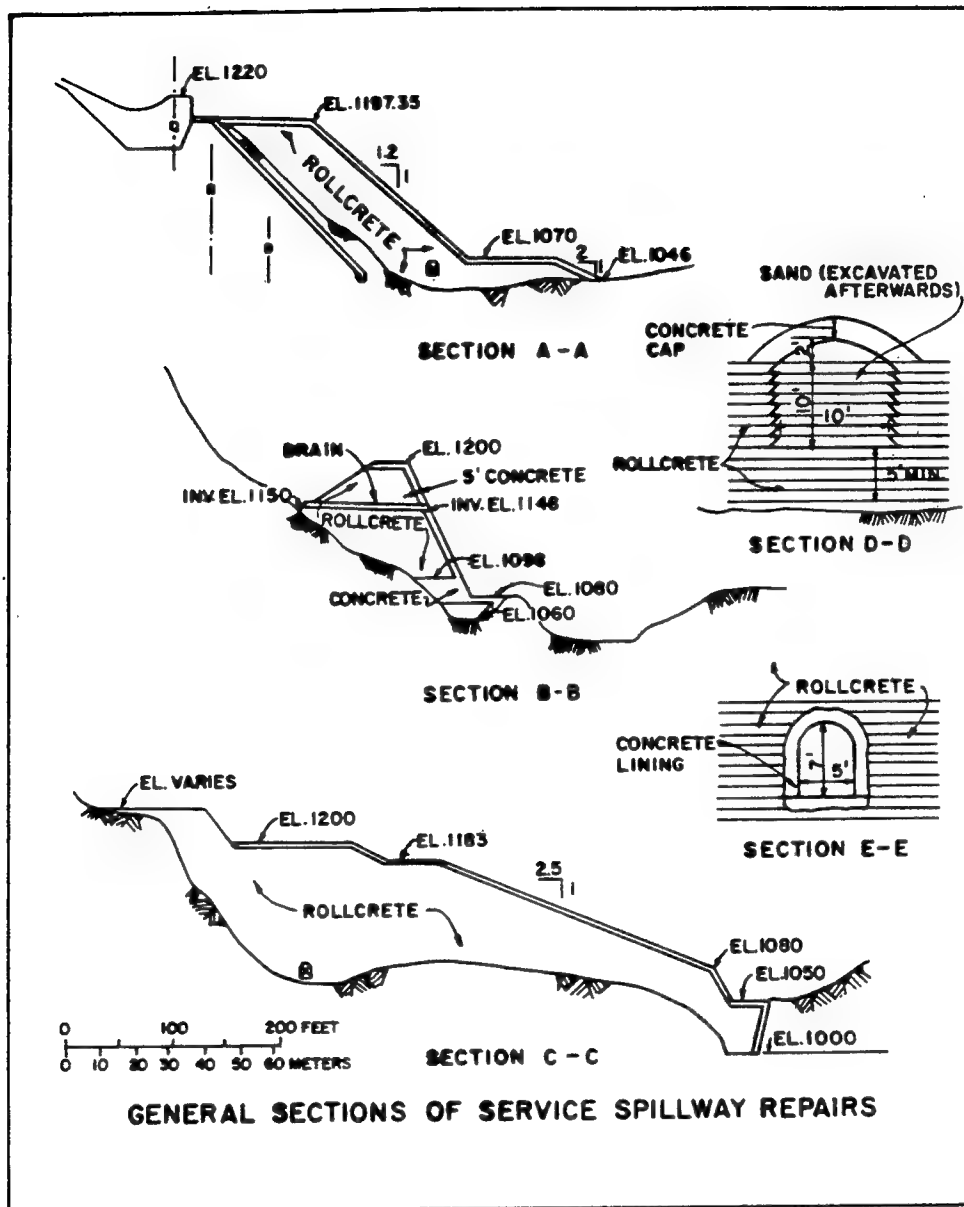
In the summer of 1977, after only 26 days of operation, the plunge pool at the service spillway was eroded to the extent that it threatened to undermine the spillway flip bucket. In addition to this damage, minor erosion was discovered downstream of the auxiliary spillway. Erosion at both locations was caused by back eddies and peripheral flows. To solve the erosion problem at the service spillway plunge pool, engineers decided to remove the rock ridge that was causing the back eddies and peripheral flows and to provide barriers on the sides of the spillway jet. At the auxiliary spillway, two minor barriers were to be constructed to stop back eddies on the left side of the plunge pool. The general plan and typical sections for the repair are shown in Figure 108.

Figure 108. Service spillway repairs at Tarbela Dam (courtesy Johnson and Chao 1979) (Continued)

The estimated amount of concrete-like material that would be needed was a minimum of 535,000 cu m (700,000 cu yd). This material would have to be produced and placed in approximately 4 months. Because of these factors, RCC was selected as the material for the project. Because there was some uncertainty about how well RCC could withstand the abrasion caused by high-velocity flows filled with debris, a decision was made to face the RCC with a 1.5-m- (5-ft-) thick layer of conventional concrete. However, conventional concrete was not placed on one RCC strut on top of the dike to the left of the plunge pool.

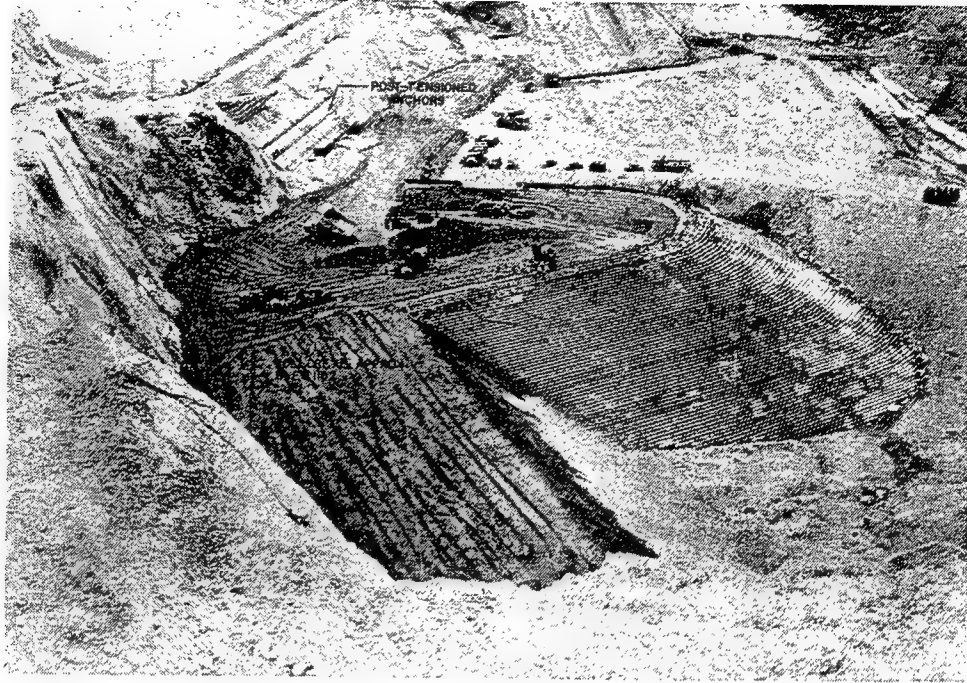
Figure 109. RCC placement at the service spillway, Tarbela Dam (courtesy of Johnson and Chao 1979)

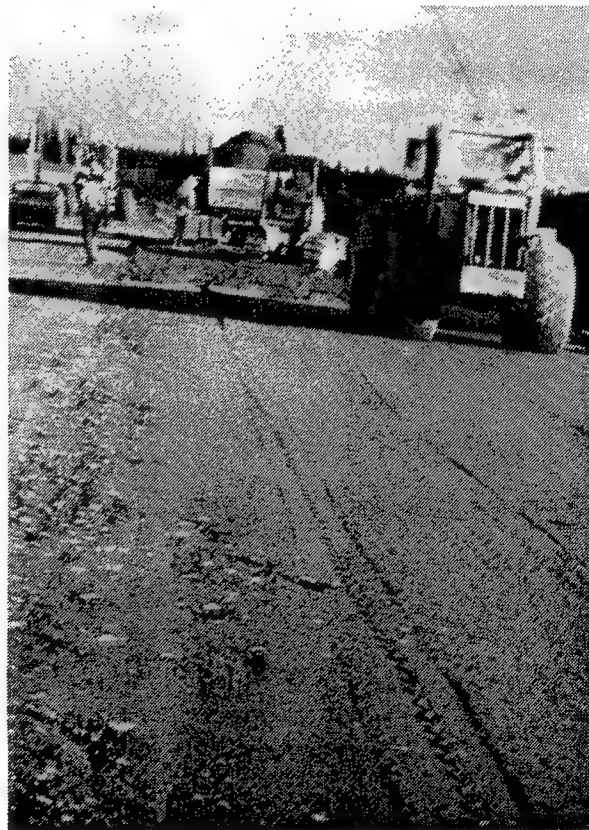
The RCC mixture for the project contained approximately 178 kg/cu m (300 lb/cu yd) of cement and 119 kg/cu m (200 lb/cu yd). The nominal maximum size of the aggregate was 38-mm (1-1/2 in.). The RCC was transported to the site in end-dump trucks where it was leveled with a dozer and compacted with a vibratory roller (Figure 110). A total of 12,770 cu m (16,700 cu

Figure 110. RCC placement at the Chena Floodway Sill (courtesy of Anderson 1984)

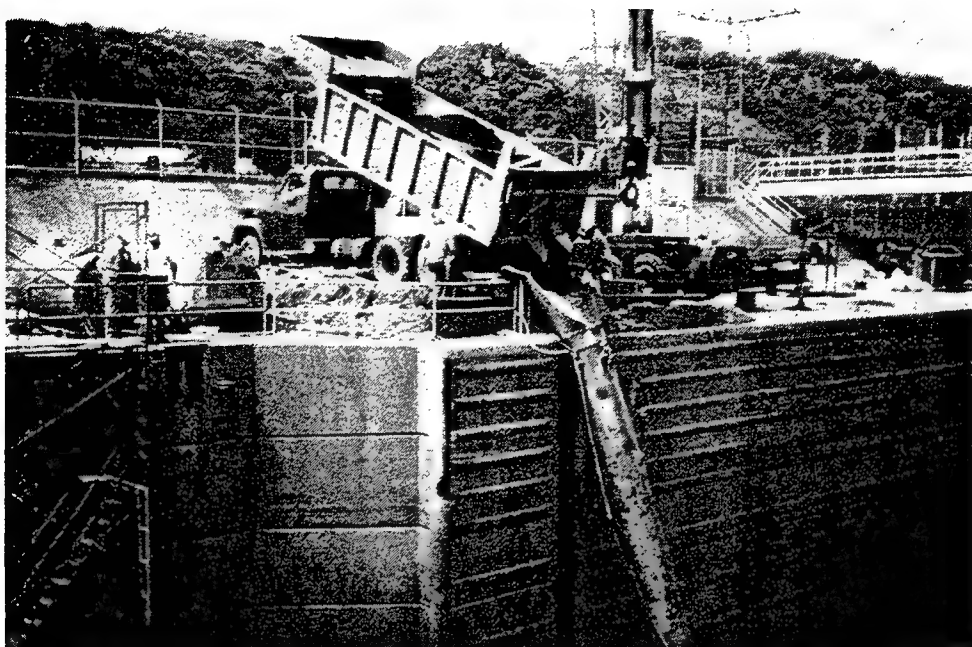
A drop pipe was used to transfer the RCC from the top of the lock wall to the lock floor where it was placed with a front end loader, leveled with a dozer, and compacted with a vibratory roller (Figures 111 through 113). The RCC was placed in 0.3-m (1-ft) layers to a maximum thickness of 1.5 m (5 ft). A total of 1,645 cu m (2,152 cu yd) of RCC was placed at a cost of \$95/cu m (\$73/cu yd).

Figure 111. RCC being dumped into a drop pipe at the top of New Cumberland Lock (courtesy of Anderson 1984)

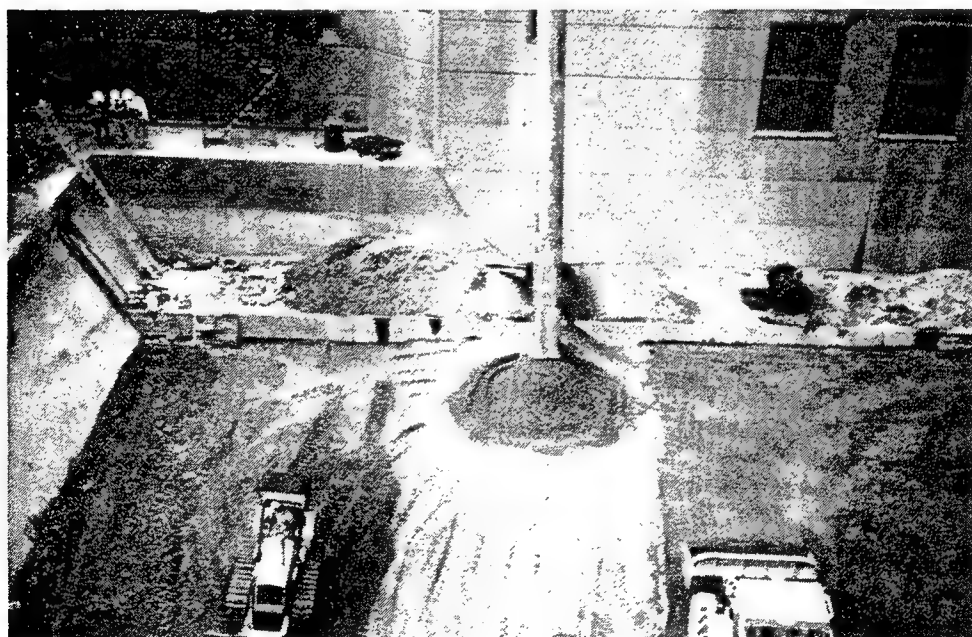
Figure 112. RCC delivered to the lock floor via a drop pipe at New Cumberland Lock (courtesy of Anderson 1984)
